# Manhole Inspection Summary

Manhole # S23C1\_019MH

Insp Date: **7/7/08 7:46 AM**

**Location** Address: **2405 Huron St**

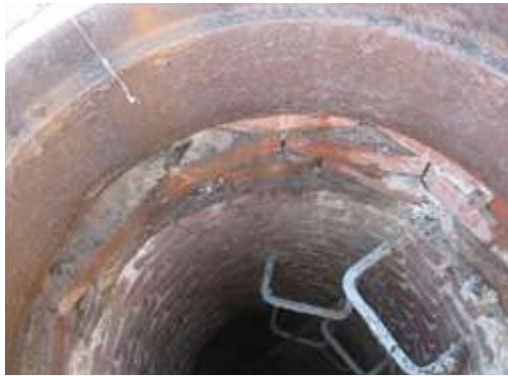
Defect 4

Condition: ☐ Sound ☐ Cracked ☒ **Leaks**

lid frame infiltration

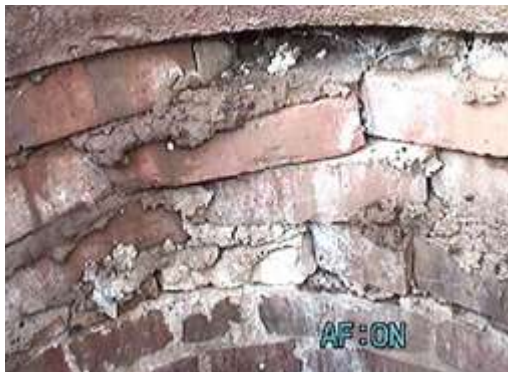
Defect 2

Condition: ☐ Sound ☐ Cracked ☐ Root Intrusion ☐ Loose Brick ☒ **Deteriorated**

Infiltration: ☐ None ☒ **Joint** ☐ Cracks ☒ **Mortar** ☐ Roots ☐ Wall

chimney deteriorated, signs of infiltration at joint & mortar

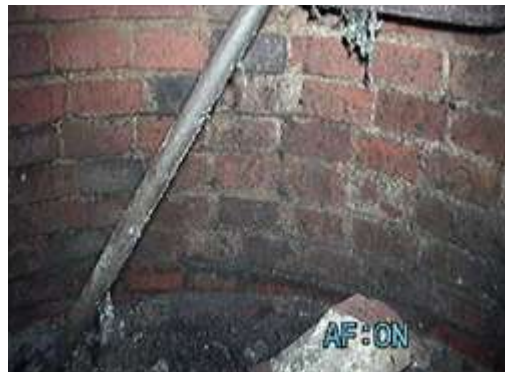
Defect 1

Condition: ☐ Sound ☐ Cracked ☐ Root Intrusion ☐ Deteriorated ☐ Leaks ☒ **Debris**

☒ **Evidence Of Surcharge** Depth: **3** (ft.) ☐ Active Surcharge Present

evidence of surcharge, channel debris
